Rivard Report | (<https://therivardreport.com/lawsuit-alleges-faulty-pipe-connection-caused-deadly-sewer-sinkhole/>)

Lawsuit Alleges Faulty Pipe Connection Caused Deadly Sewer Sinkhole

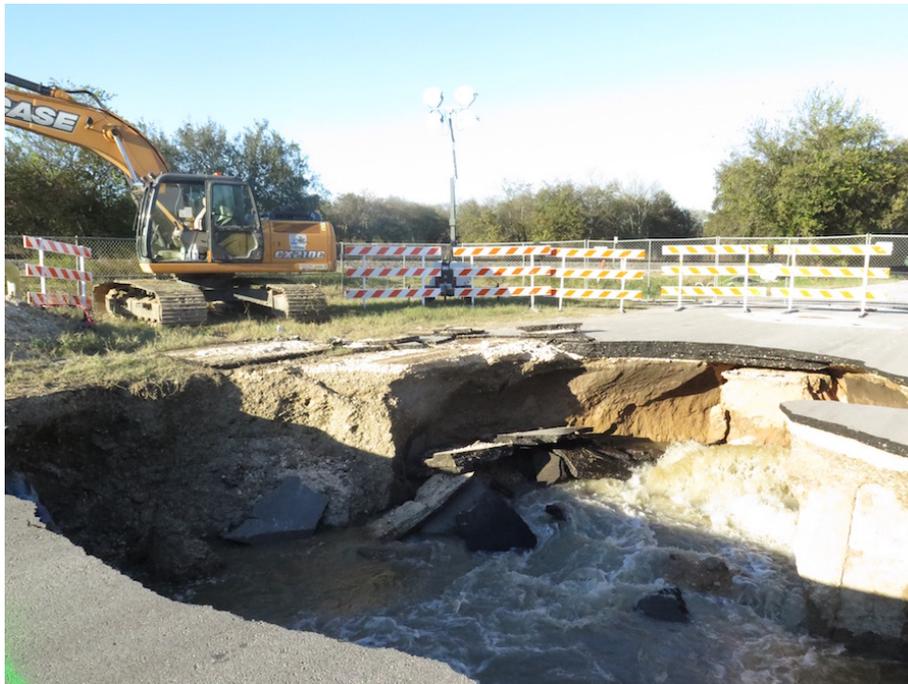
Water rapidly flows from a broken pipe into a sinkhole at 8414 Quintana Road in December 2016.

In Cantu's view, shortcuts on both the engineering and construction of a temporary connection between old and new pipes led to the leak. Sewage escaping from the line eroded the ground beneath the asphalt, which crumbled into the newly formed pit below.

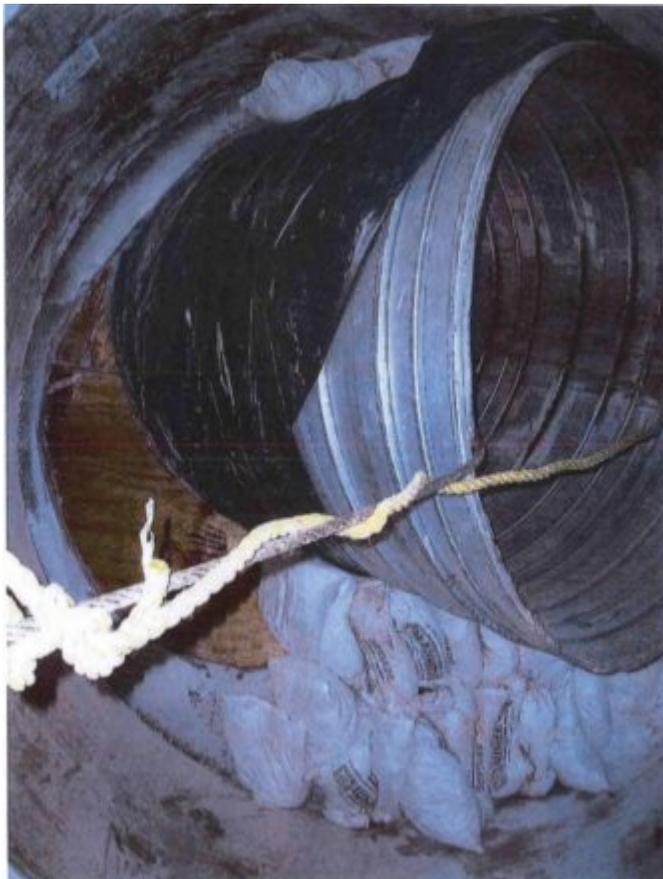
A connection between sewer lines below Quintana Road.

The suit alleges that the sewage leaks first began at a junction box, a cube of concrete, that was connected to a temporary pipe made of corrugated metal 54 inches in diameter.

The temporary pipe's connection to the junction box used a frame of plywood supported by sandbags.

Givler wrote that this connection couldn't handle the intense forces caused by the flowing sewage, which began leaking and scouring out the dirt that was filled in around the connection to provide additional support.

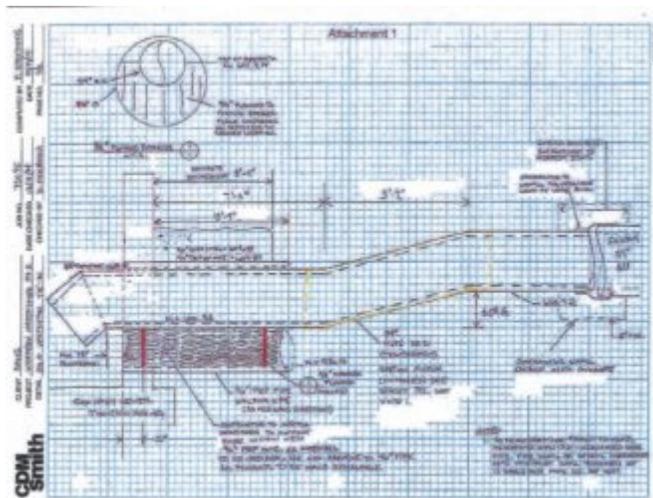
Hand-drawn engineering plans for a pipe connection that used corrugated metal pipe, plywood, and sandbags.

One was the use of corrugated metal pipe, typically used in drainage culverts, in a sewage job, which typically requires fiberglass reinforced pipe, high-density polyethylene, or concrete. He also said he has never seen a plywood-and-sandbag connection or a hand-drawn engineering plan submitted for approval.
